**SINKHOLE MONITORING REPORT  
EVALUATION PERFORMED ON  
DECEMBER 15, 2021  
ANDREWS QUARRY  
WILLIAMSBURG COUNTY, SC**

American Materials Company  
1410 Commonwealth Drive, Ste. 201  
Wilmington, North Carolina 28403

March 10, 2022

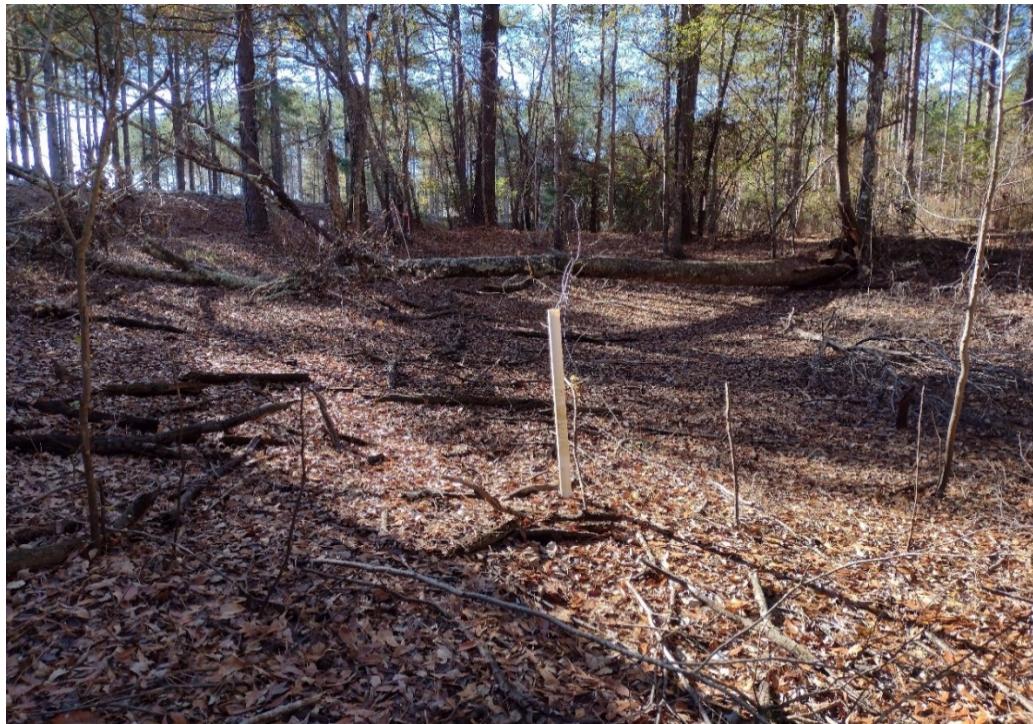
*Picture 1: Sinkhole #1 with no signs of water or sinkhole activity. Note the dry staff gage installed by AMC.*

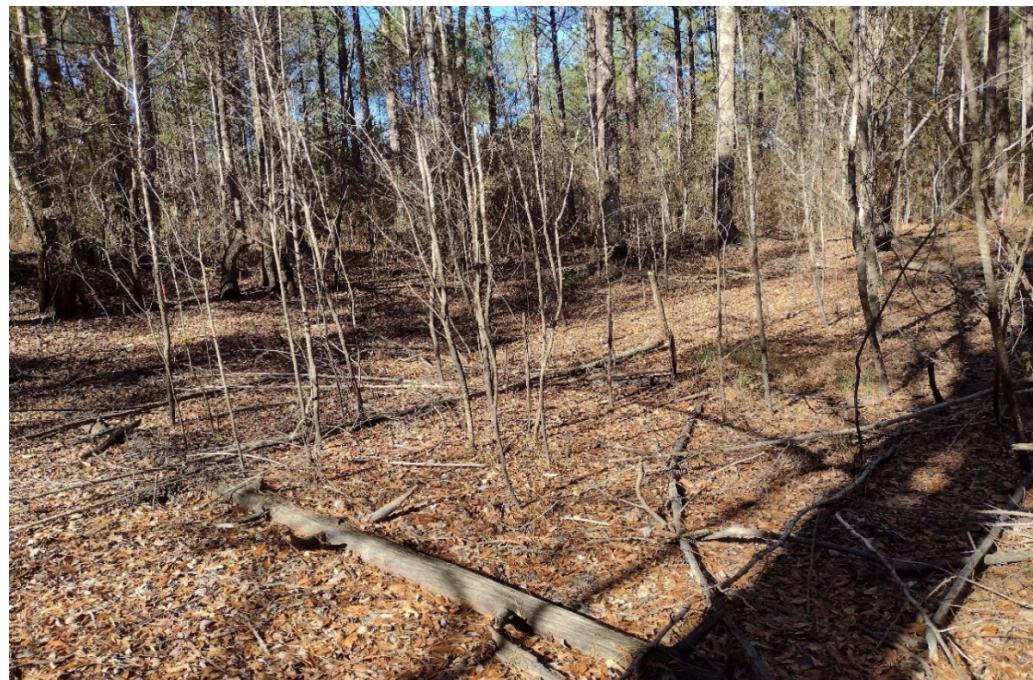
*Picture 2: Sinkhole #1 with no signs of water or sinkhole activity*

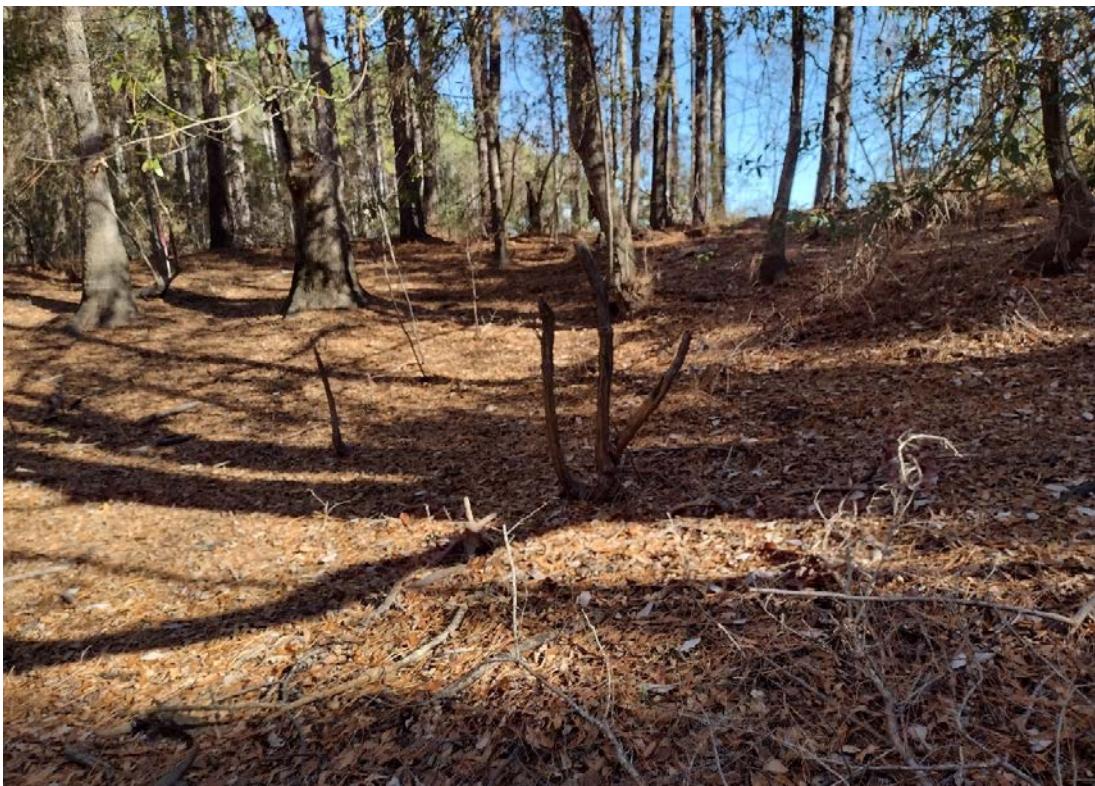
*Picture 3: Sinkhole #1 with no signs of water or sinkhole activity*

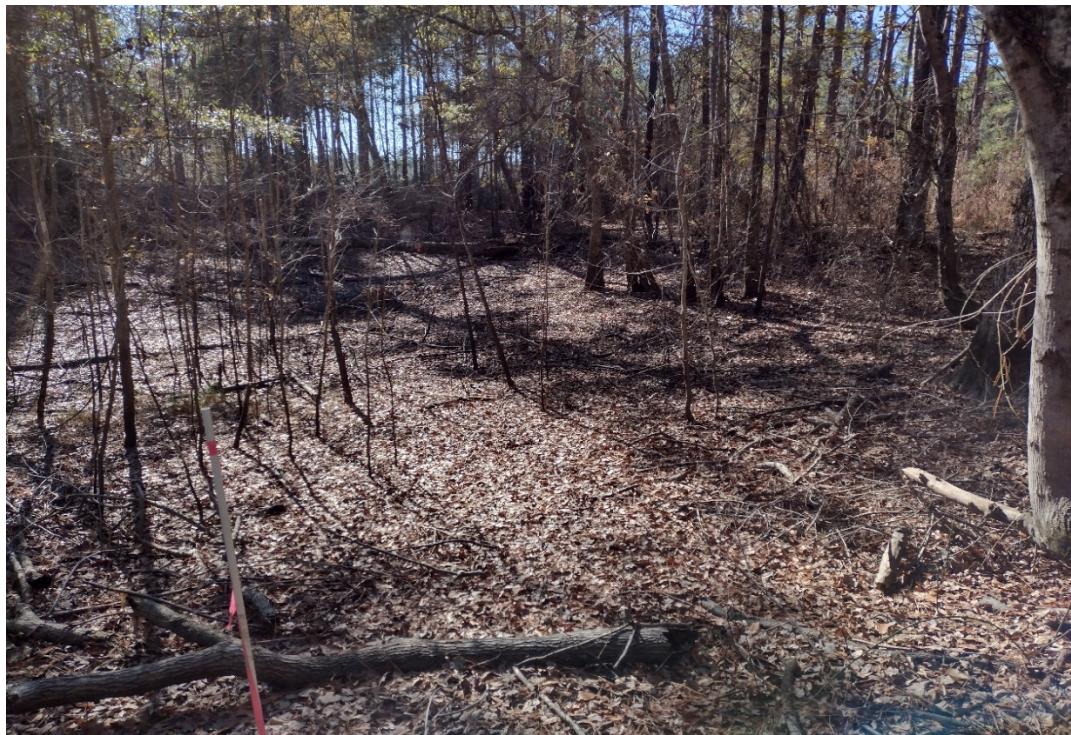
*Picture 4: Sinkhole #1 with no signs of water or sinkhole activity*

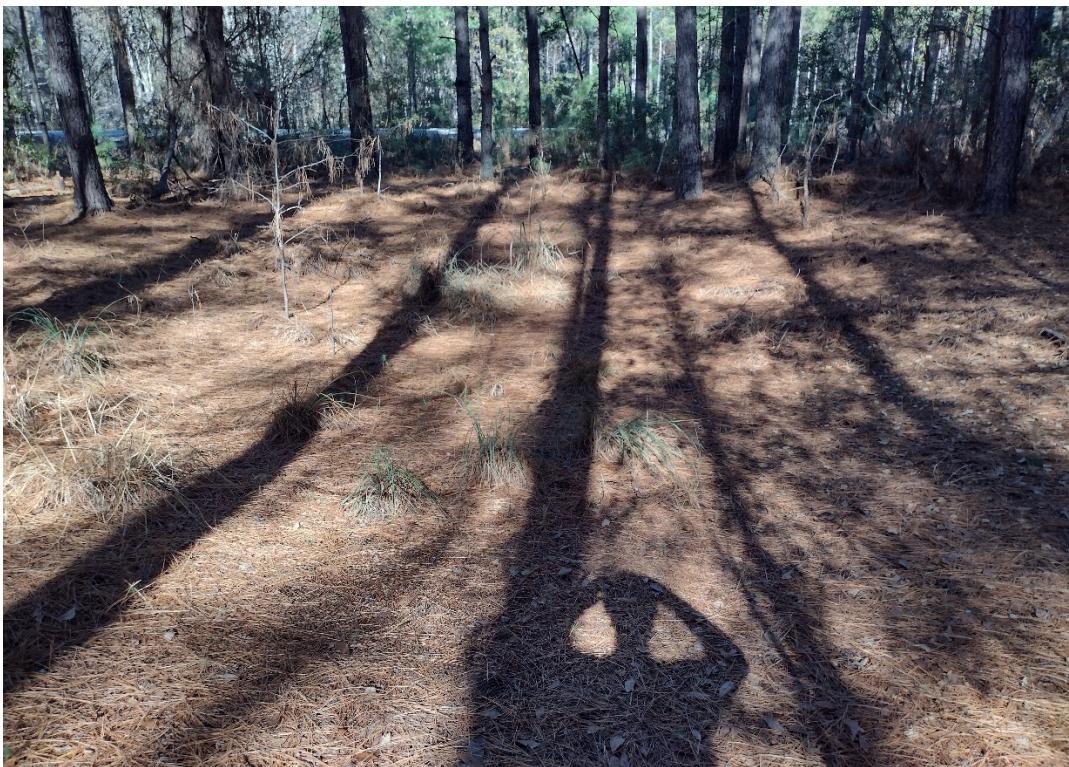
*Picture 5: Sinkhole #2 with no signs of water or sinkhole activity*

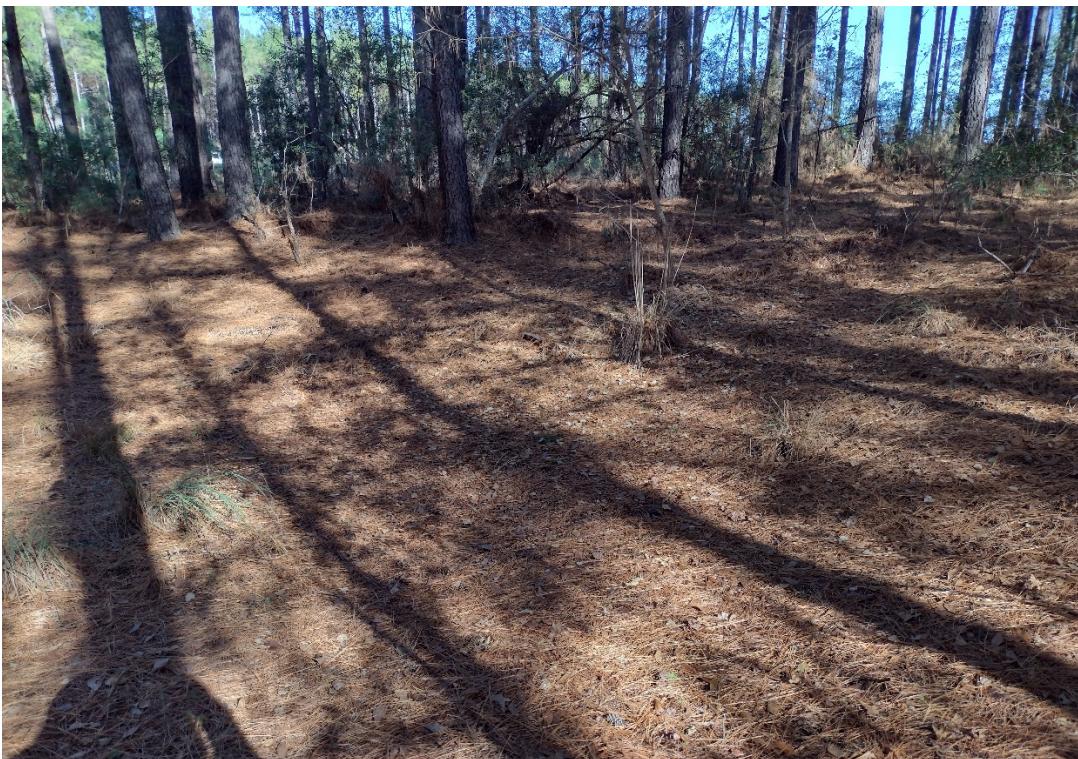
*Picture 6: Sinkhole #2 with no signs of water or sinkhole activity*

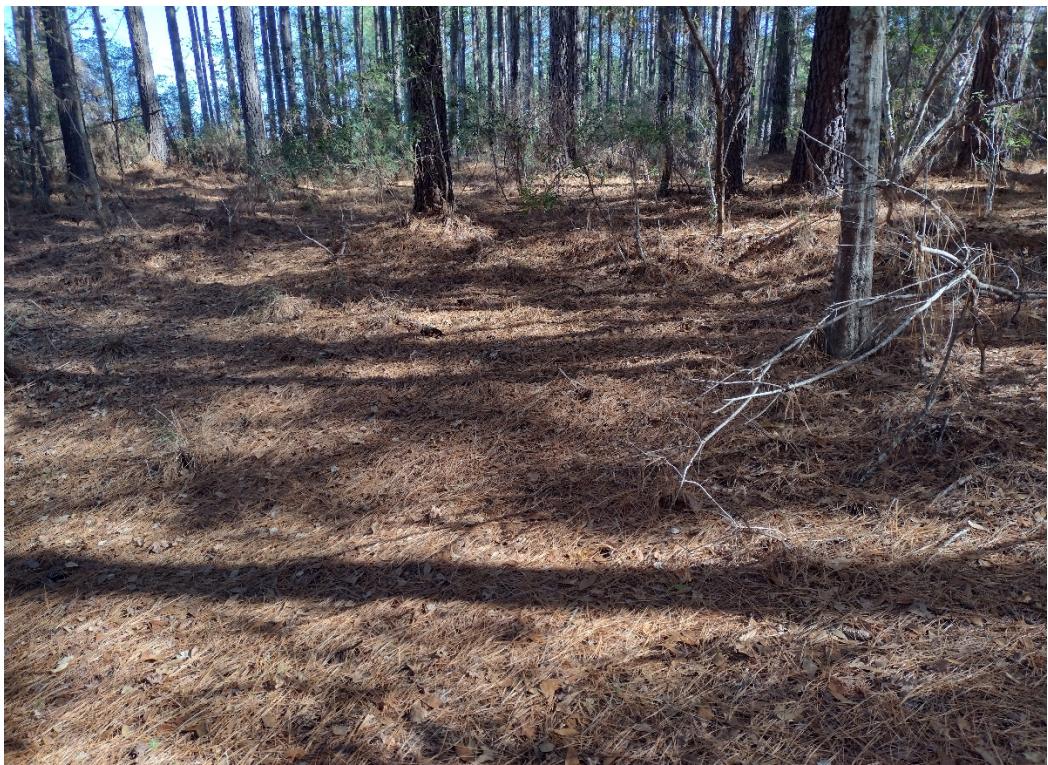
*Picture 7: Sinkhole #2 with no signs of water or sinkhole activity*

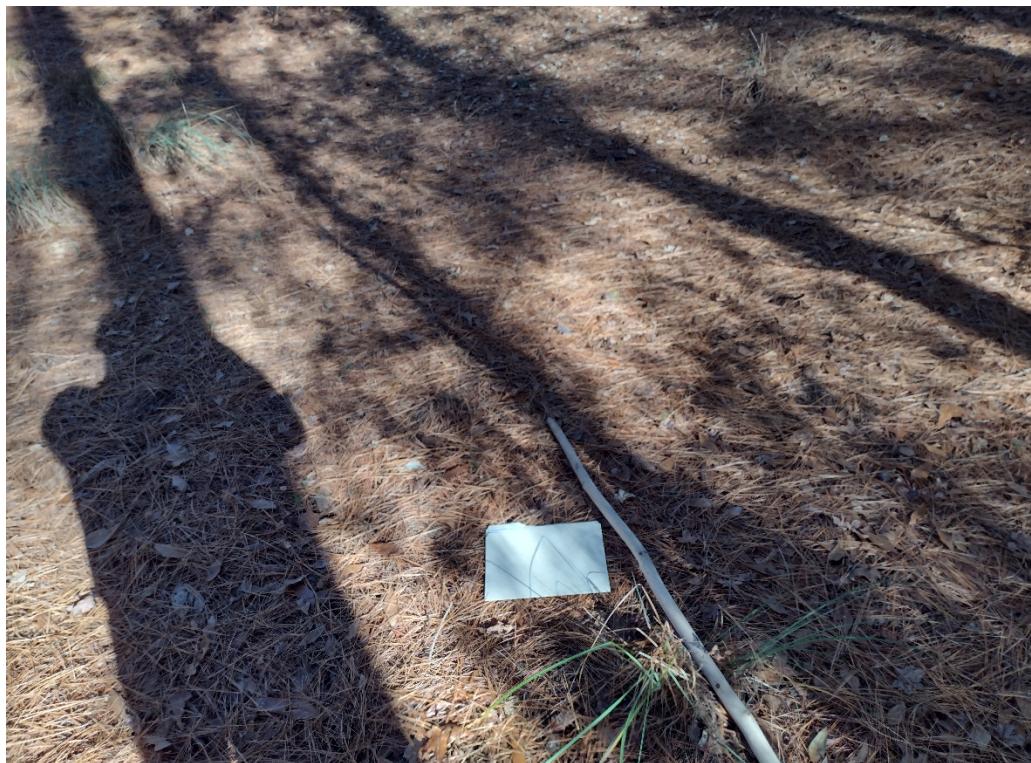
*Picture 8: Sinkhole #2 with no signs of water or sinkhole activity*

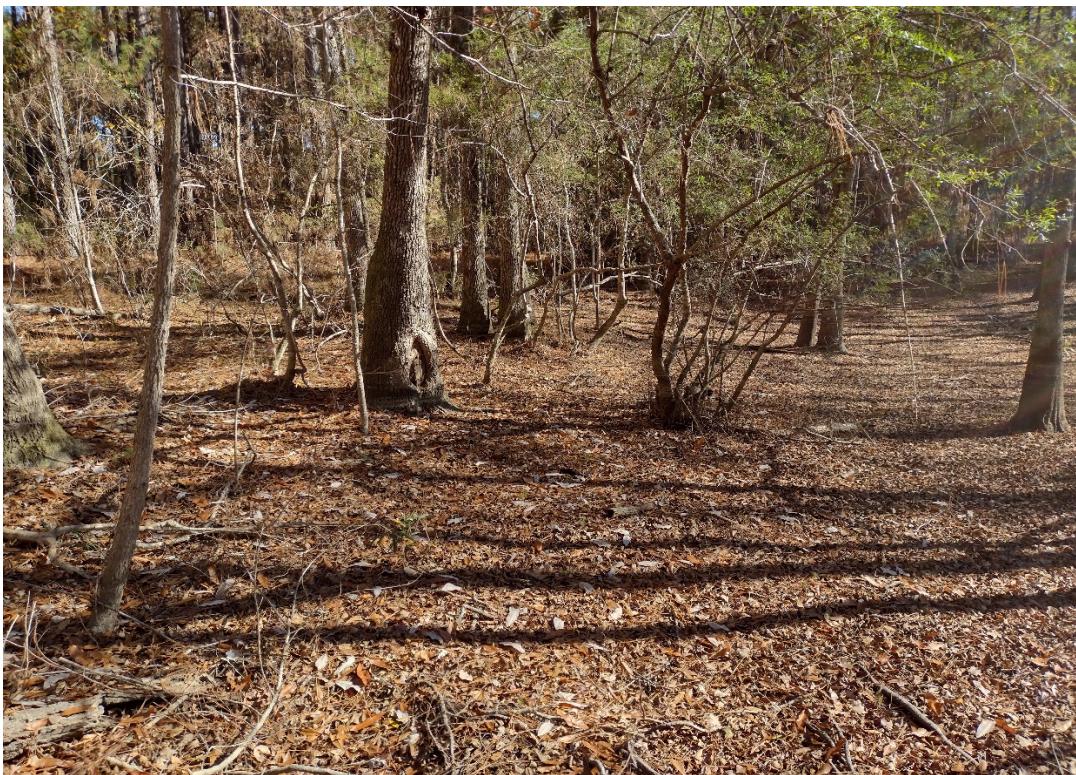
*Picture 9: Sinkhole #3 with no signs of water or sinkhole activity*

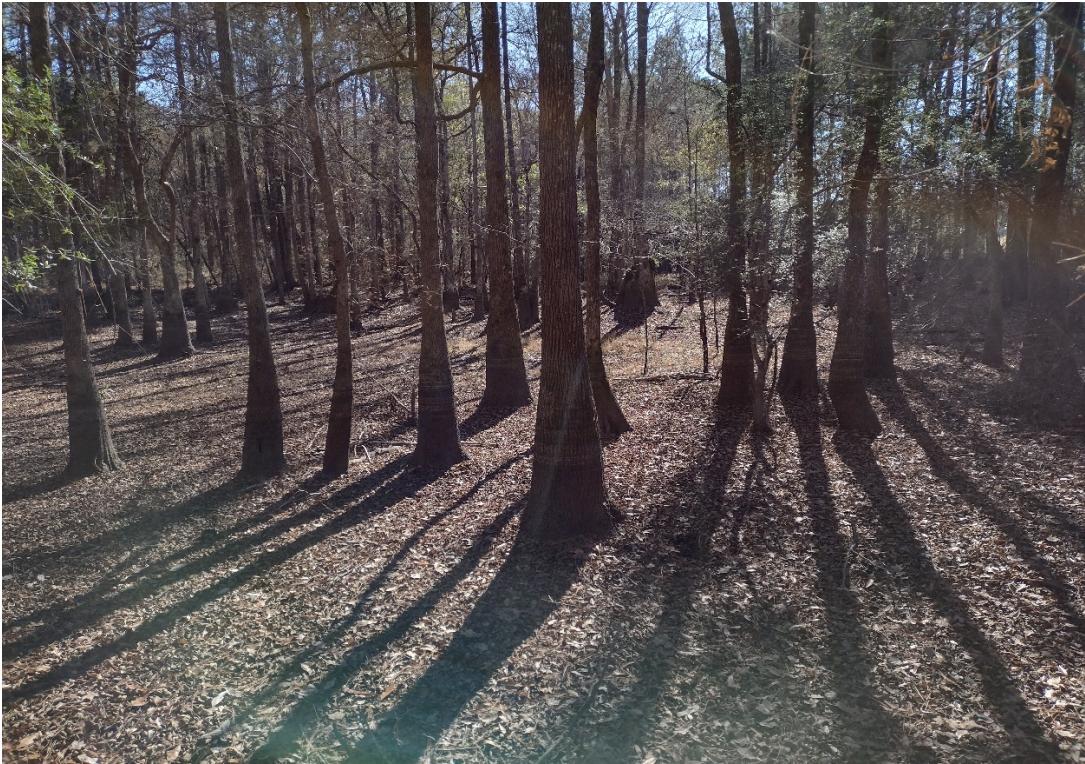
*Picture 10: Sinkhole #3 with no signs of water or sinkhole activity*

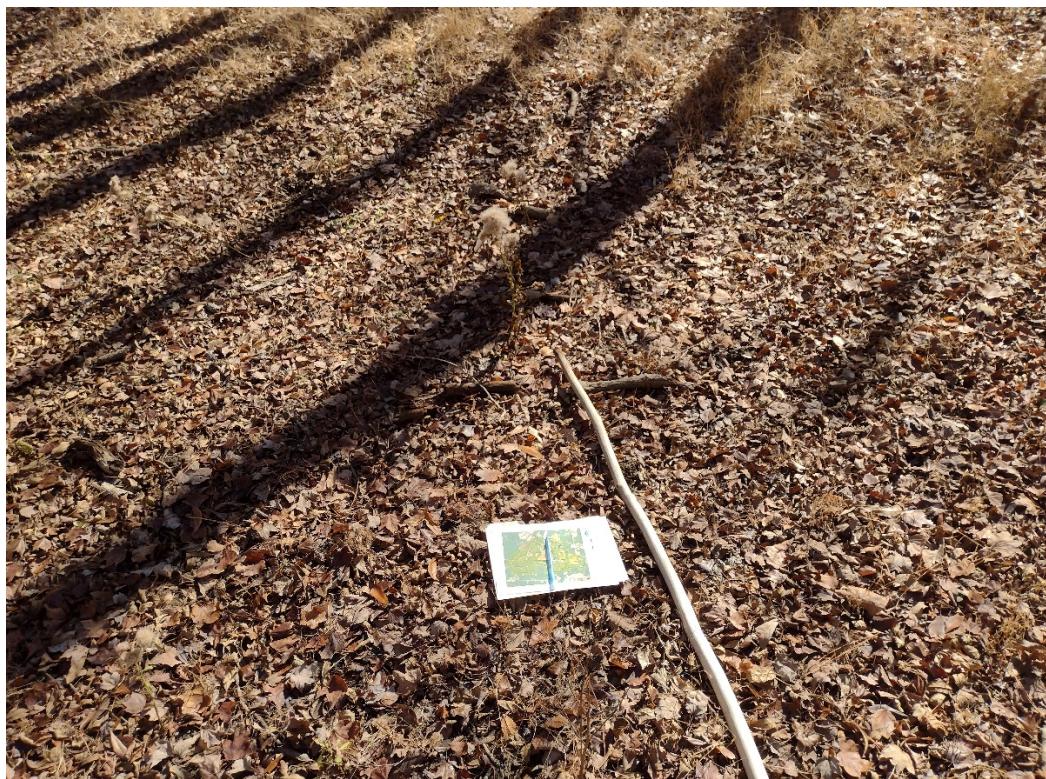
*Picture 11: Sinkhole #3 with no signs of water or sinkhole activity*

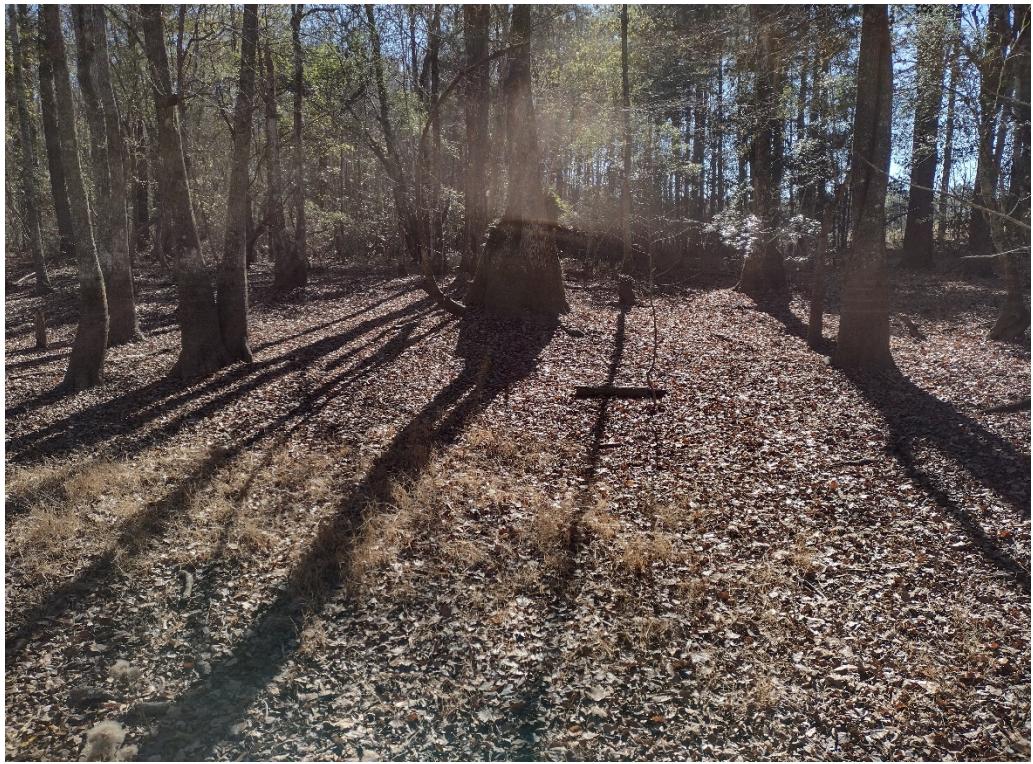
*Picture 12: Sinkhole #3 with no signs of water or sinkhole activity*

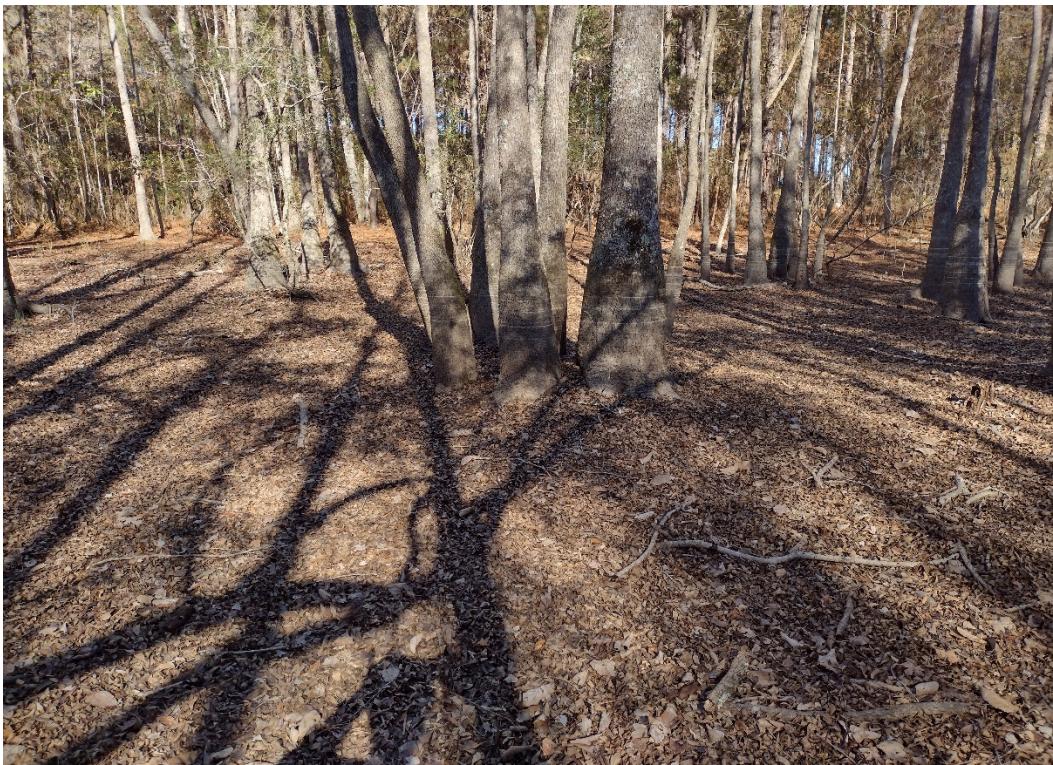
*Picture 13: Sinkhole #4 with no signs of water or sinkhole activity*

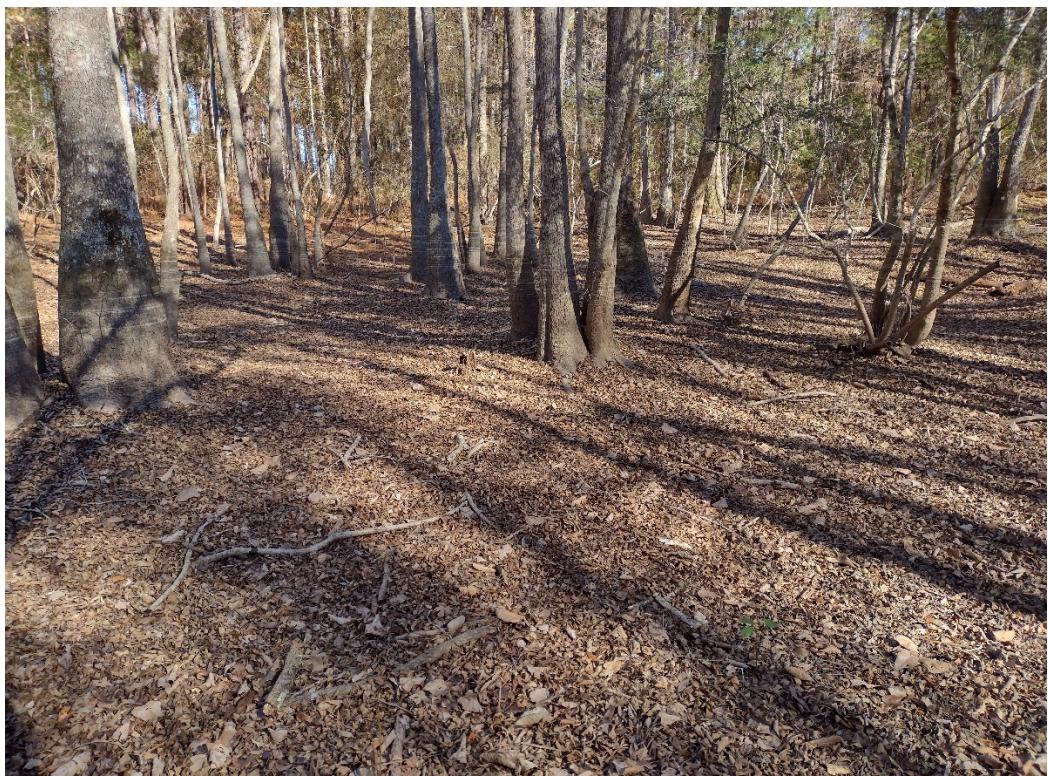
*Picture 14: Sinkhole #4 with no signs of water or sinkhole activity*

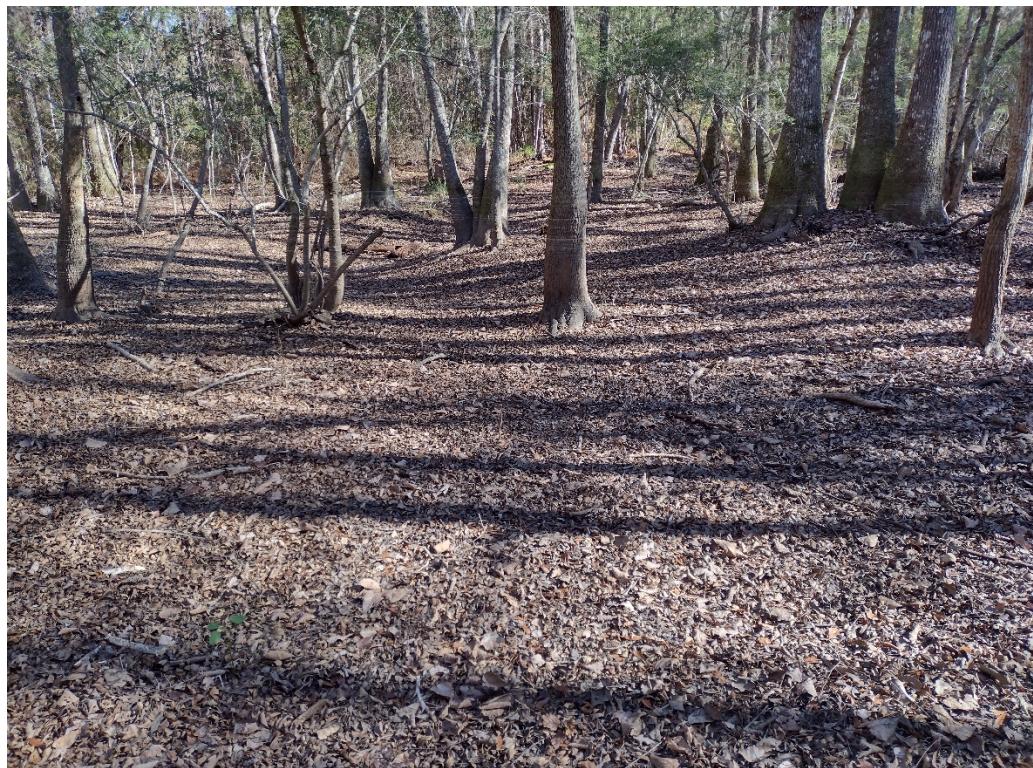
*Picture 15: Sinkhole #4 with no signs of water or sinkhole activity*

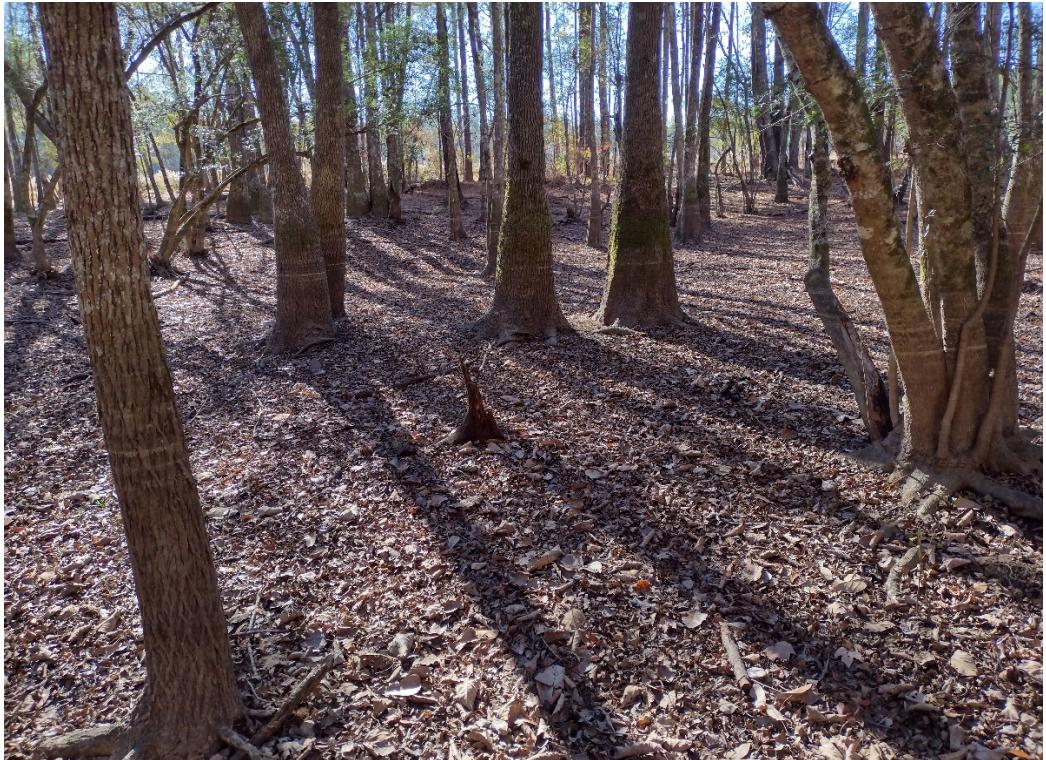
*Picture 16: Sinkhole #4 with no signs of water or sinkhole activity*

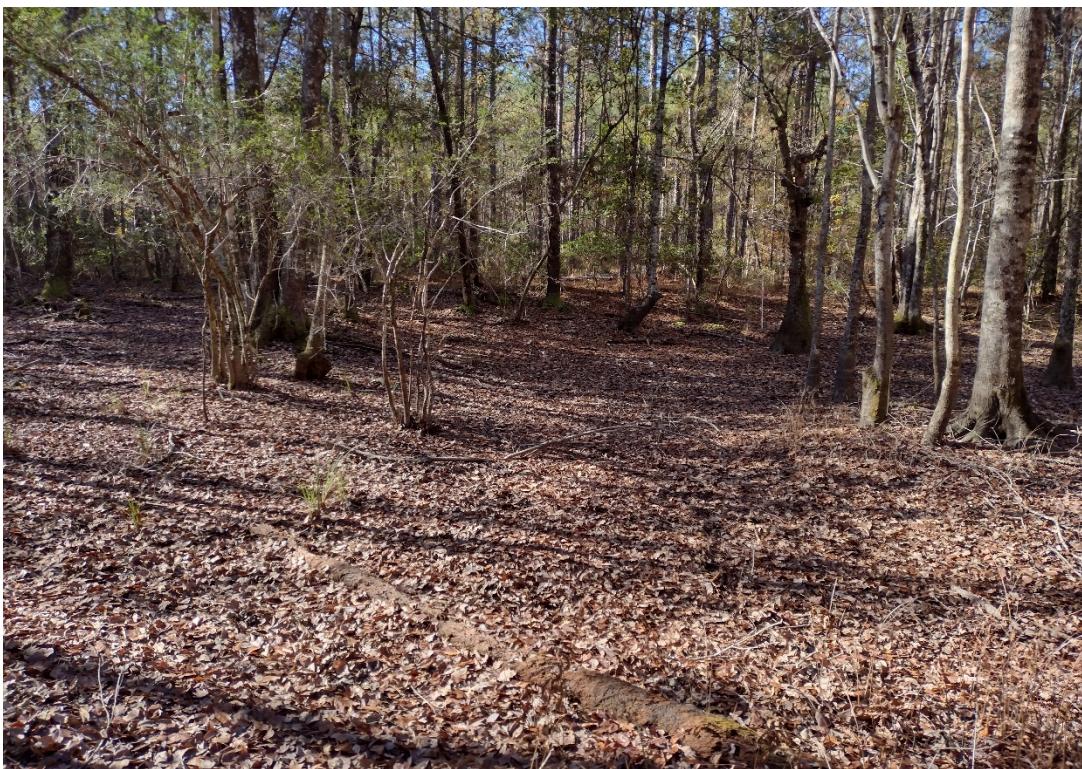
*Picture 17: Sinkhole #5 with no signs of water or sinkhole activity*

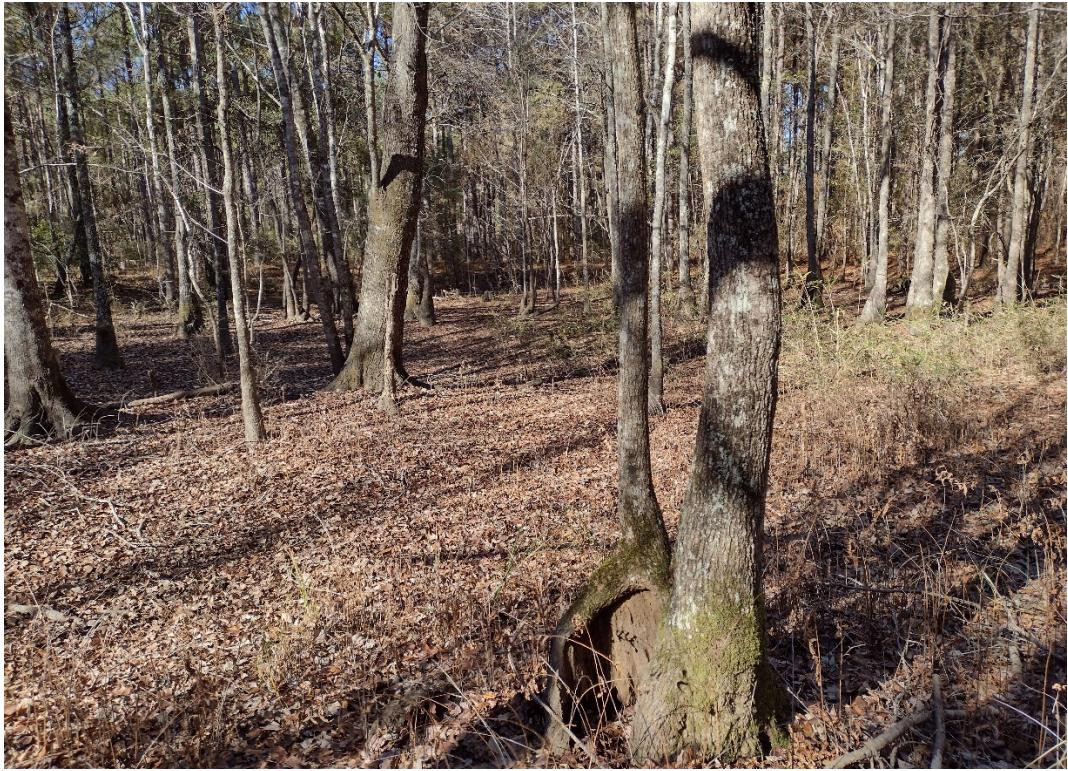
*Picture 18: Sinkhole #5 with no signs of water or sinkhole activity*

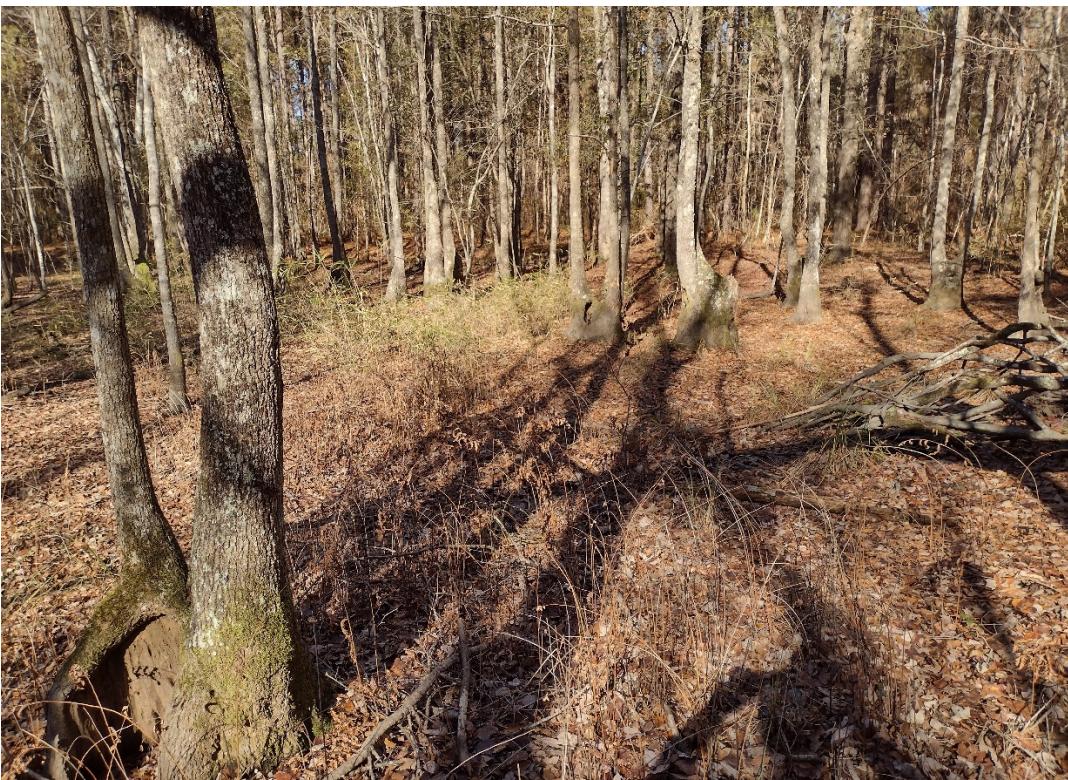
*Picture 19: Sinkhole #5 with no signs of water or sinkhole activity*

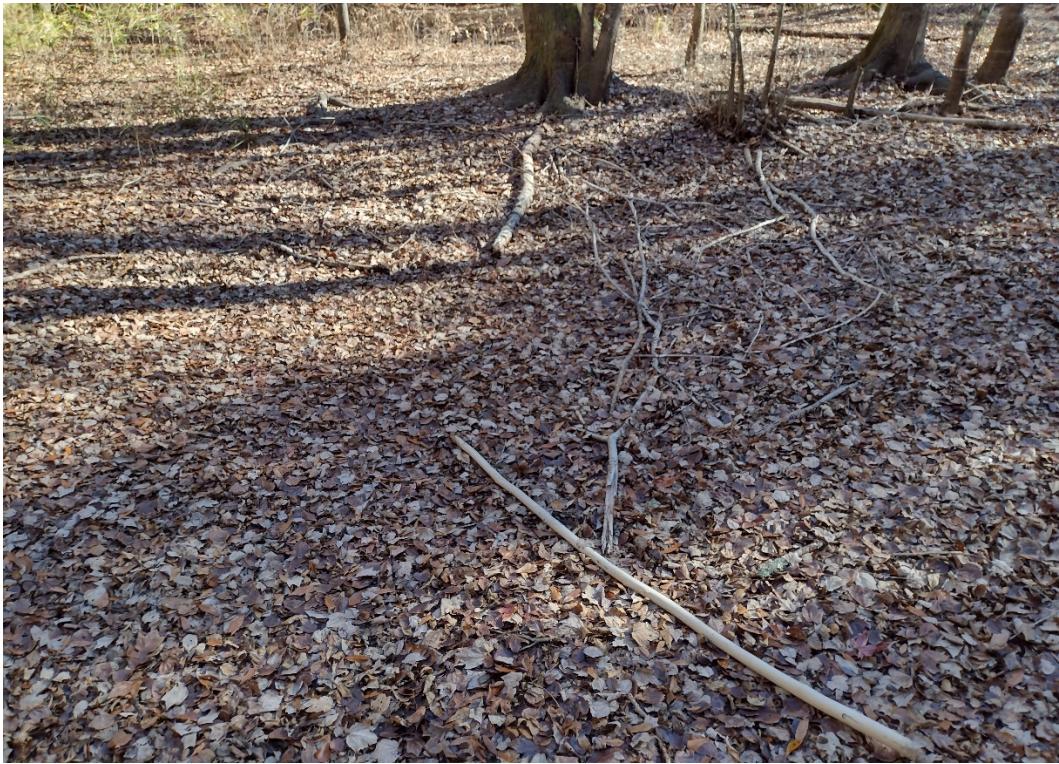
*Picture 20: Sinkhole #5 with no signs of water or sinkhole activity*

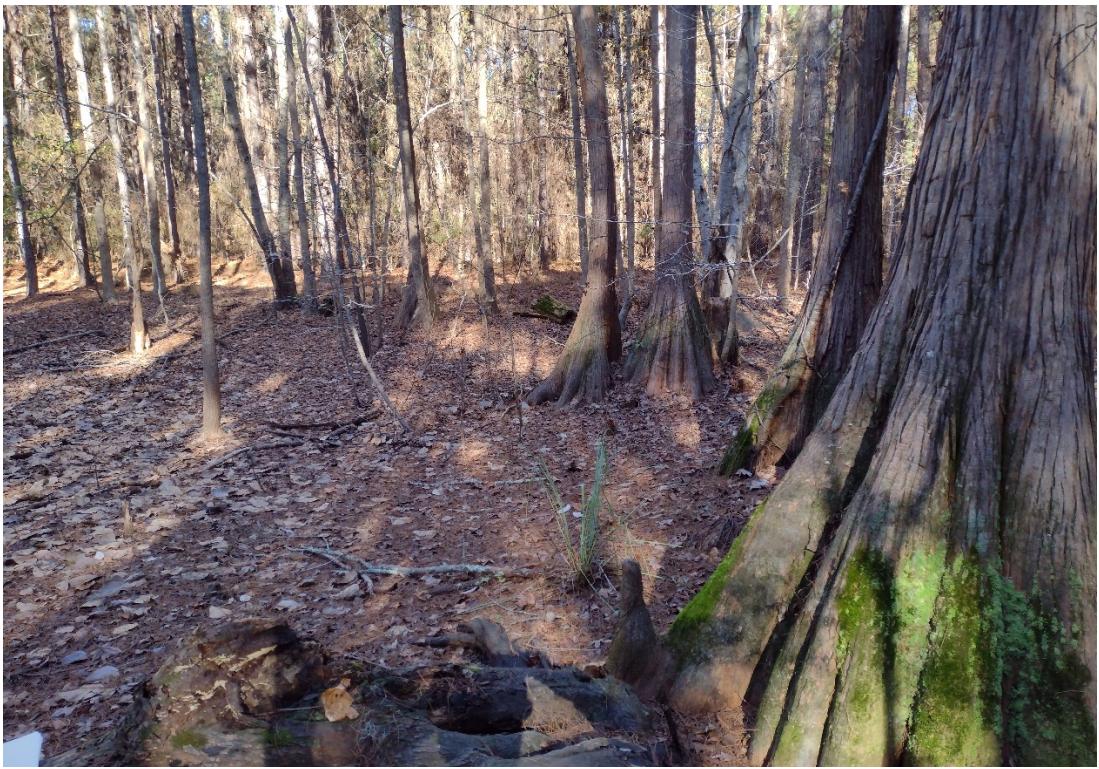
*Picture 21: Sinkhole #6 with no signs of water or sinkhole activity*

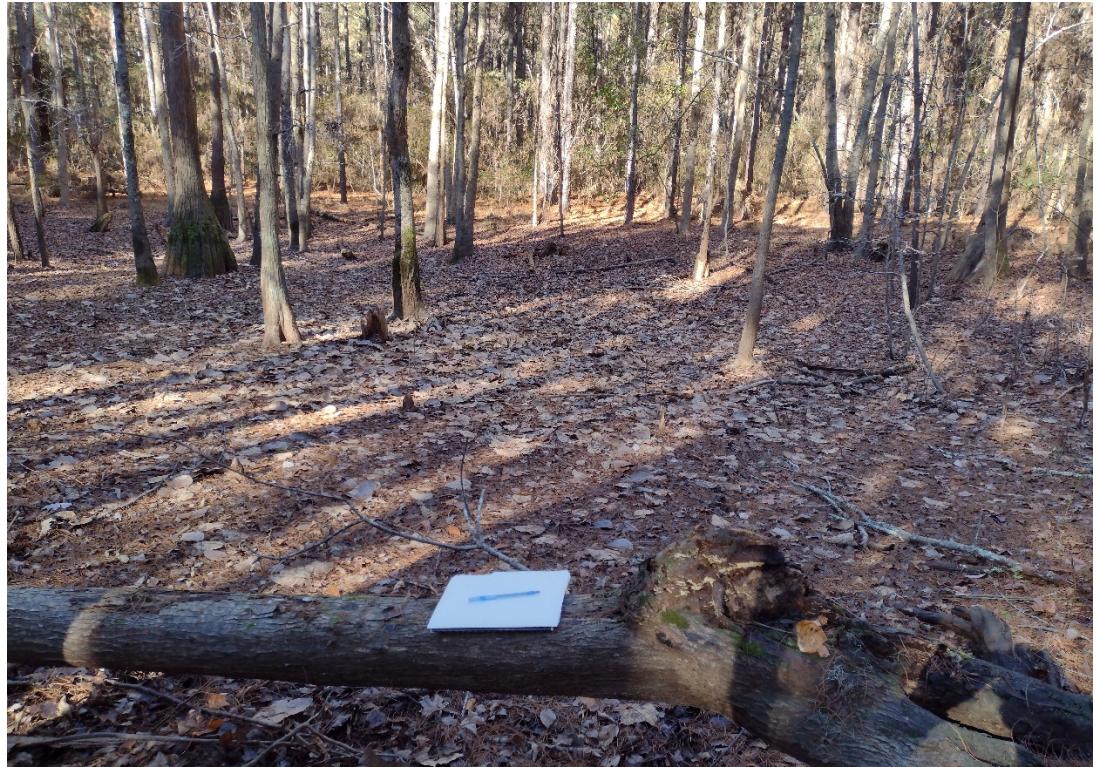
*Picture 22: Sinkhole #6 with no signs of water or sinkhole activity*

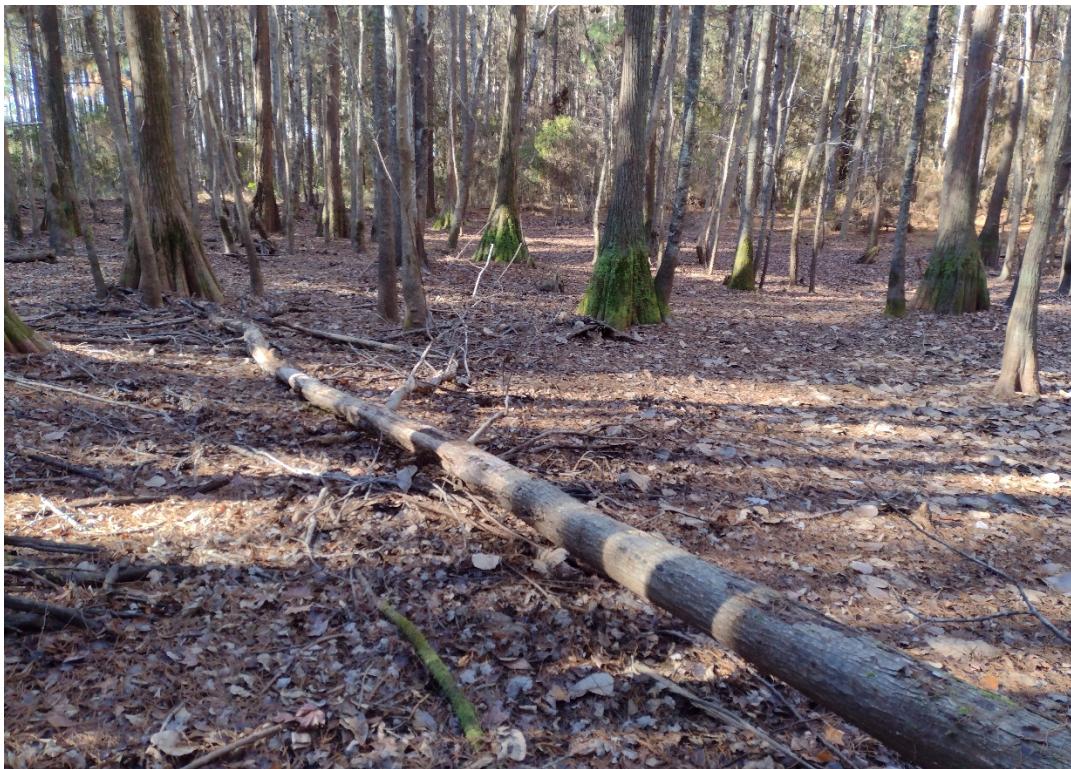
*Picture 23: Sinkhole #6 with no signs of water or sinkhole activity*

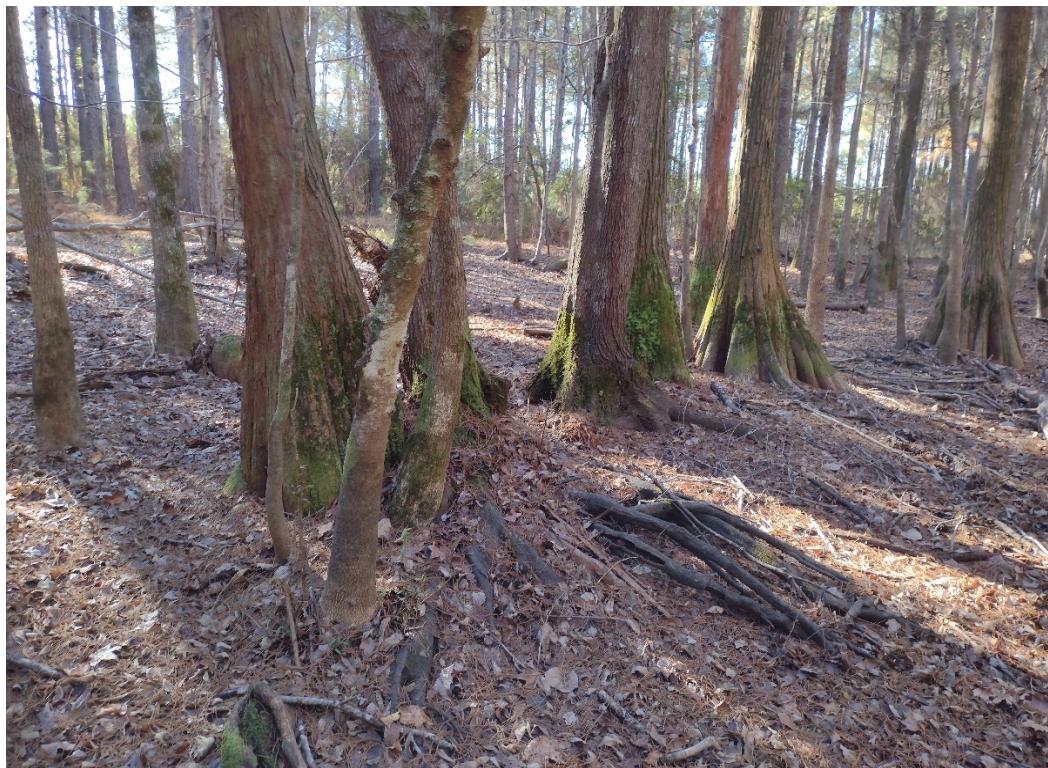
*Picture 24: Sinkhole #6 with no signs of water or sinkhole activity*

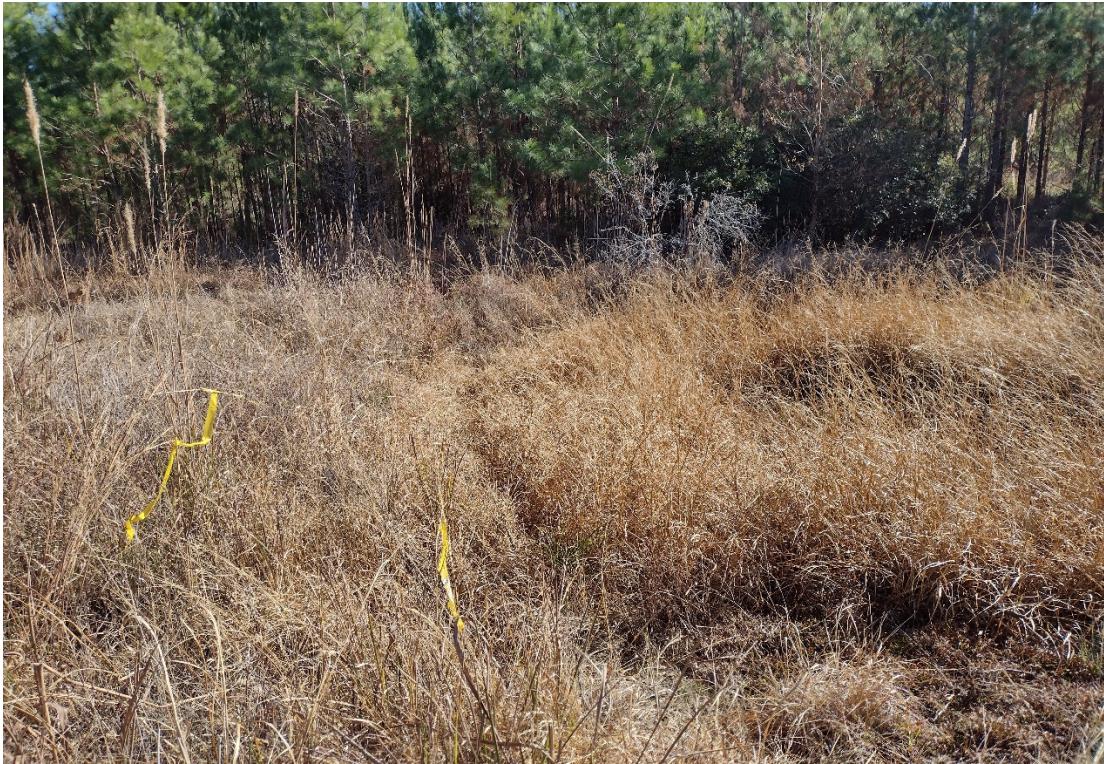
*Picture 25: Sinkhole #7 with no signs of water or sinkhole activity*

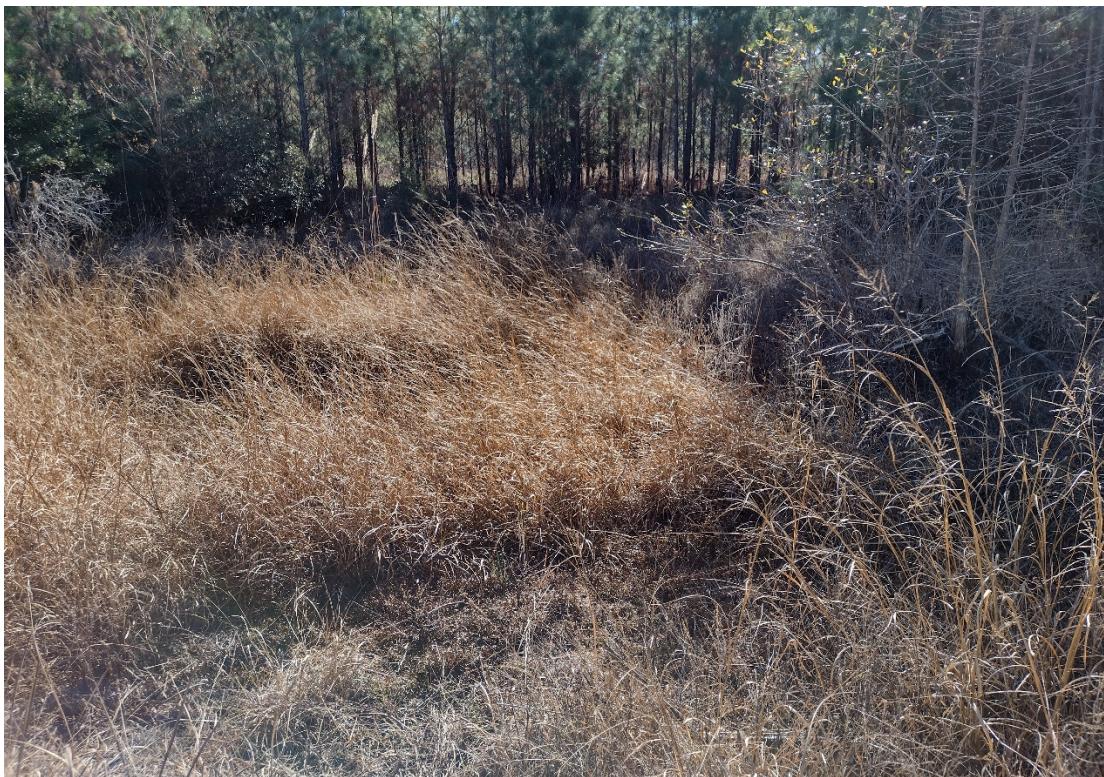
*Picture 26: Sinkhole #7 with no signs of water or sinkhole activity*

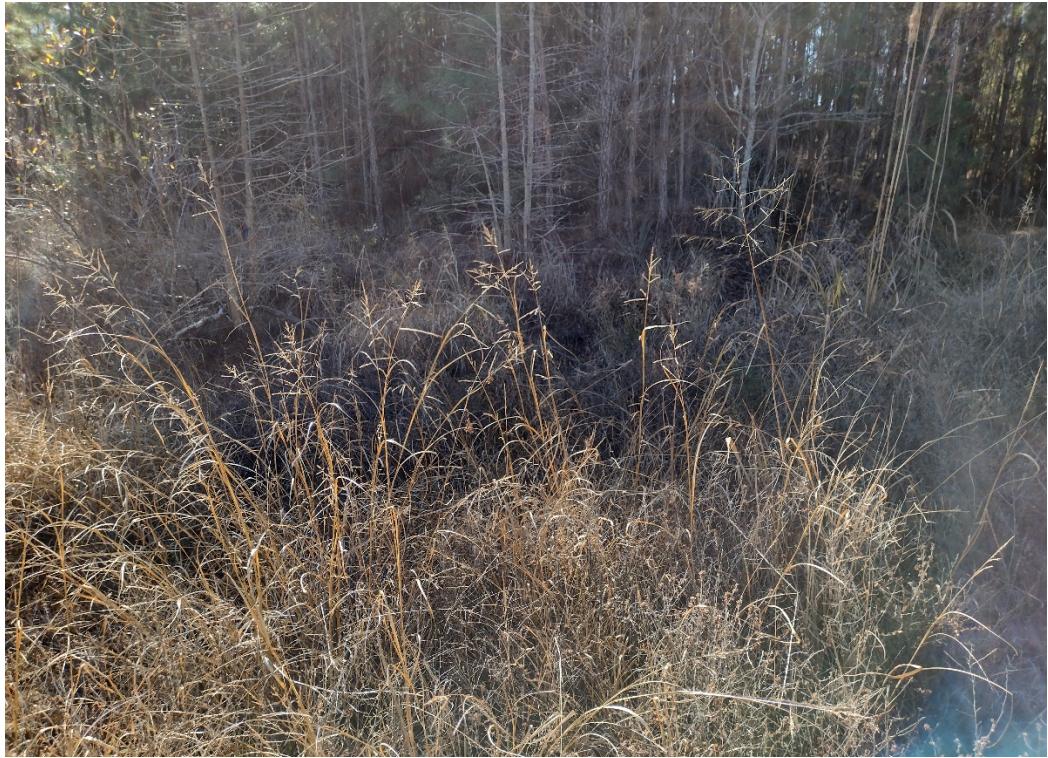
Picture 27: Sinkhole #7 with no signs of water or sinkhole activity

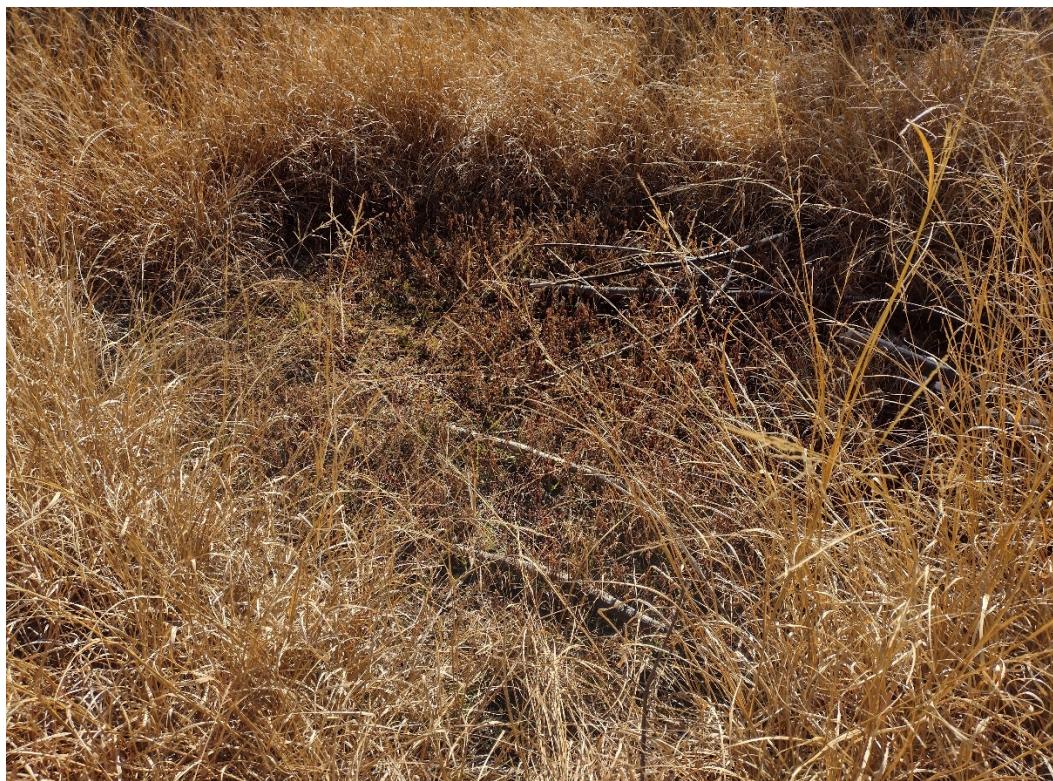
Picture 28: Sinkhole #7 with no signs of water or sinkhole activity
