**SINKHOLE MONITORING REPORT  
EVALUATION PERFORMED ON  
DECEMBER 15, 2021  
ANDREWS QUARRY  
WILLIAMSBURG COUNTY, SC**

American Materials Company  
1410 Commonwealth Drive, Ste. 201  
Wilmington, North Carolina 28403

March 10, 2022

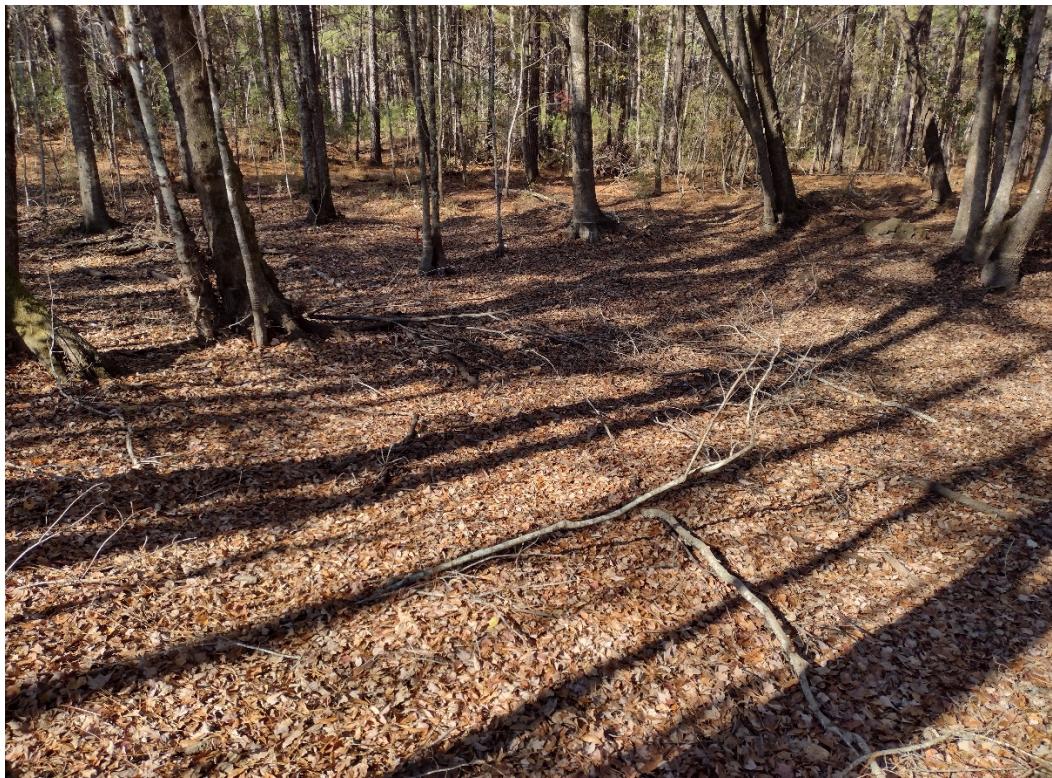
*Picture 29: Sinkhole #8 with no signs of water or sinkhole activity*

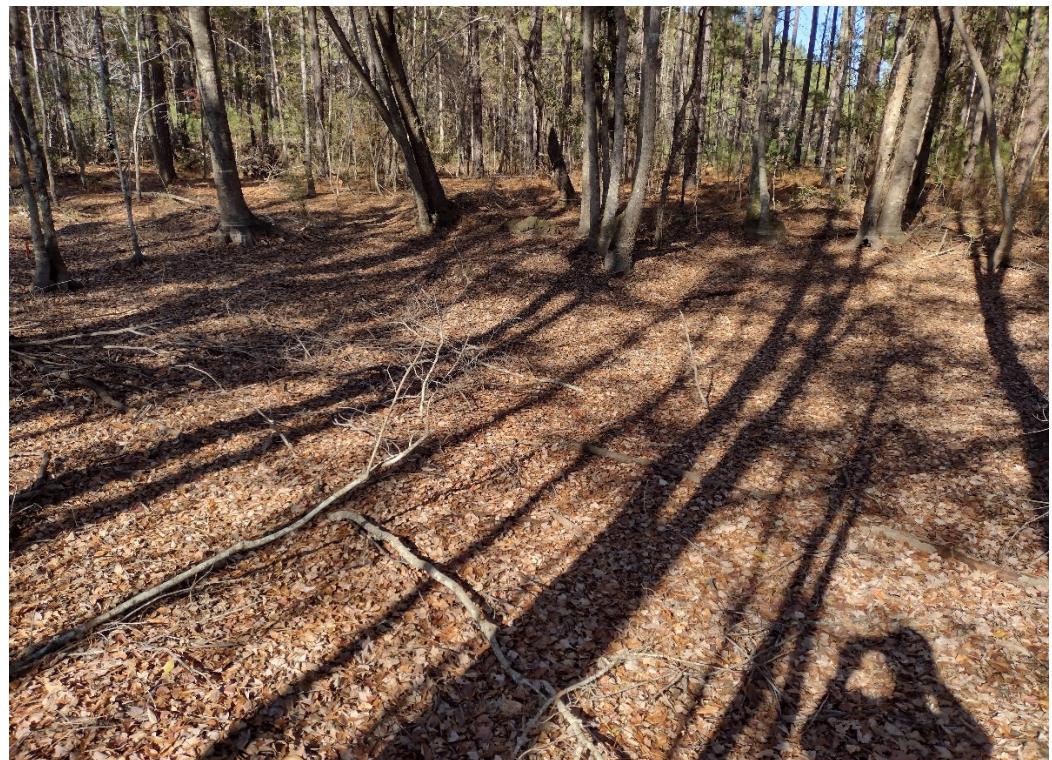
*Picture 30: Sinkhole #8 with no signs of water or sinkhole activity*

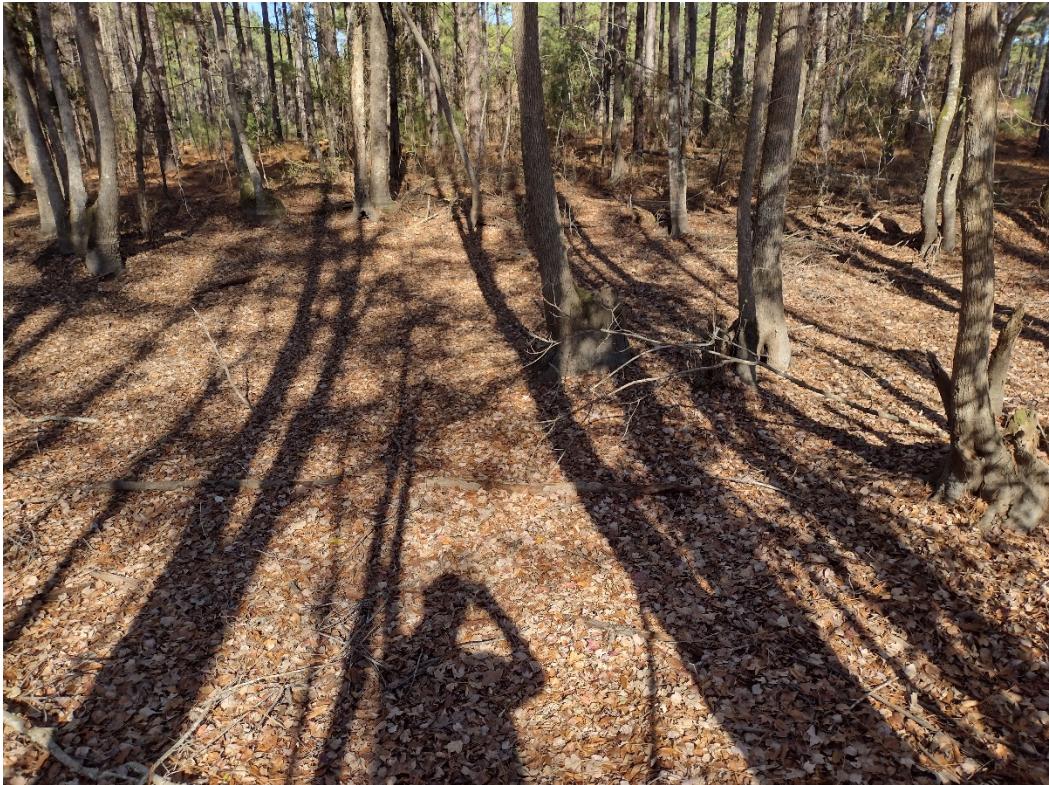
*Picture 31: Sinkhole #8 with no signs of water or sinkhole activity*

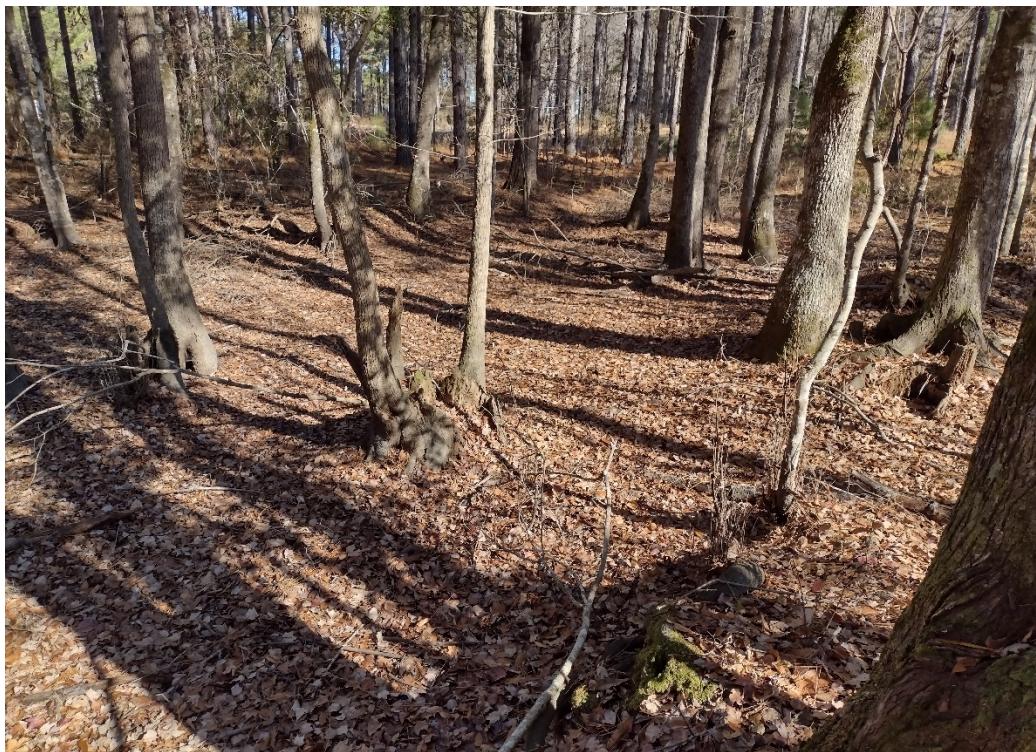
*Picture 32: Sinkhole #8 with no signs of water or sinkhole activity*

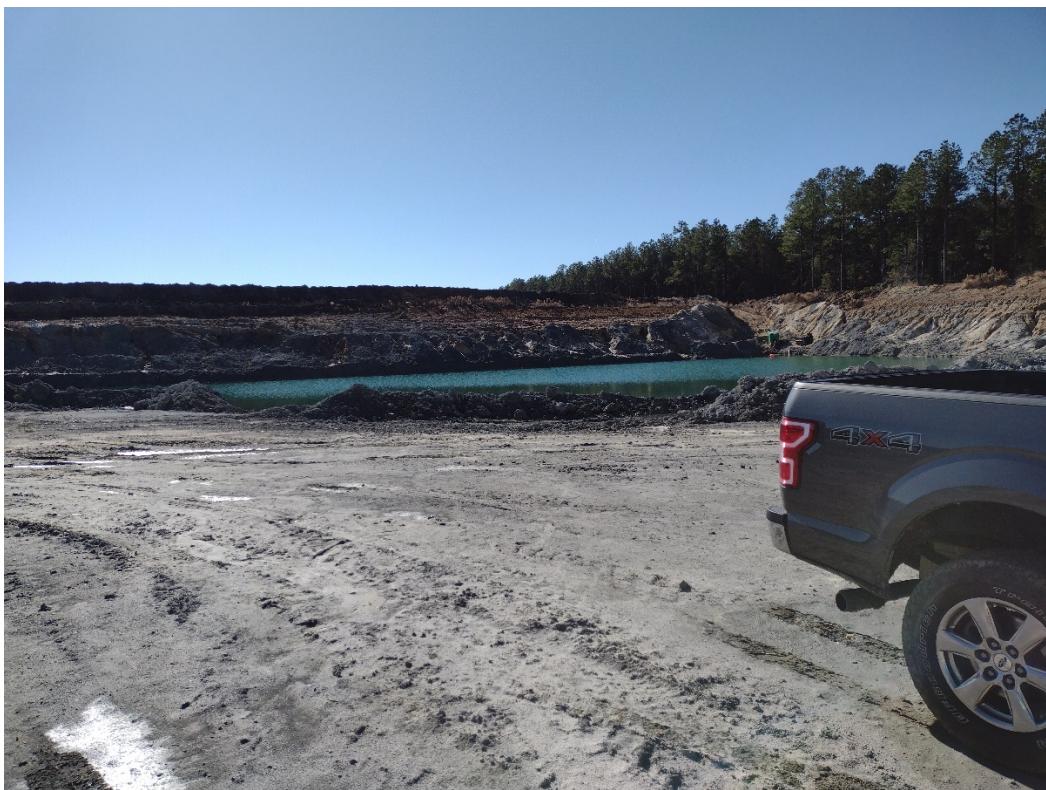
During GMA's site visit, AMC was not actively pumping groundwater from the pit. GMA observed the water level in the open pit to be approximately at the top of the limestone. Attachment IV includes an image of the active mine pit showing the water level during the December 15, 2021 site visit. It appears that, as of December 2021, mining activities have had a minor effect of about 3 feet of decline in water levels in the limestone monitoring wells closest

*Active Mine Pit Showing Water Level near the Top of the Limestone Ore*
