**SINKHOLE MONITORING REPORT  
EVALUATION PERFORMED ON  
DECEMBER 15, 2021  
ANDREWS QUARRY  
WILLIAMSBURG COUNTY, SC**

American Materials Company  
1410 Commonwealth Drive, Ste. 201  
Wilmington, North Carolina 28403

March 10, 2022

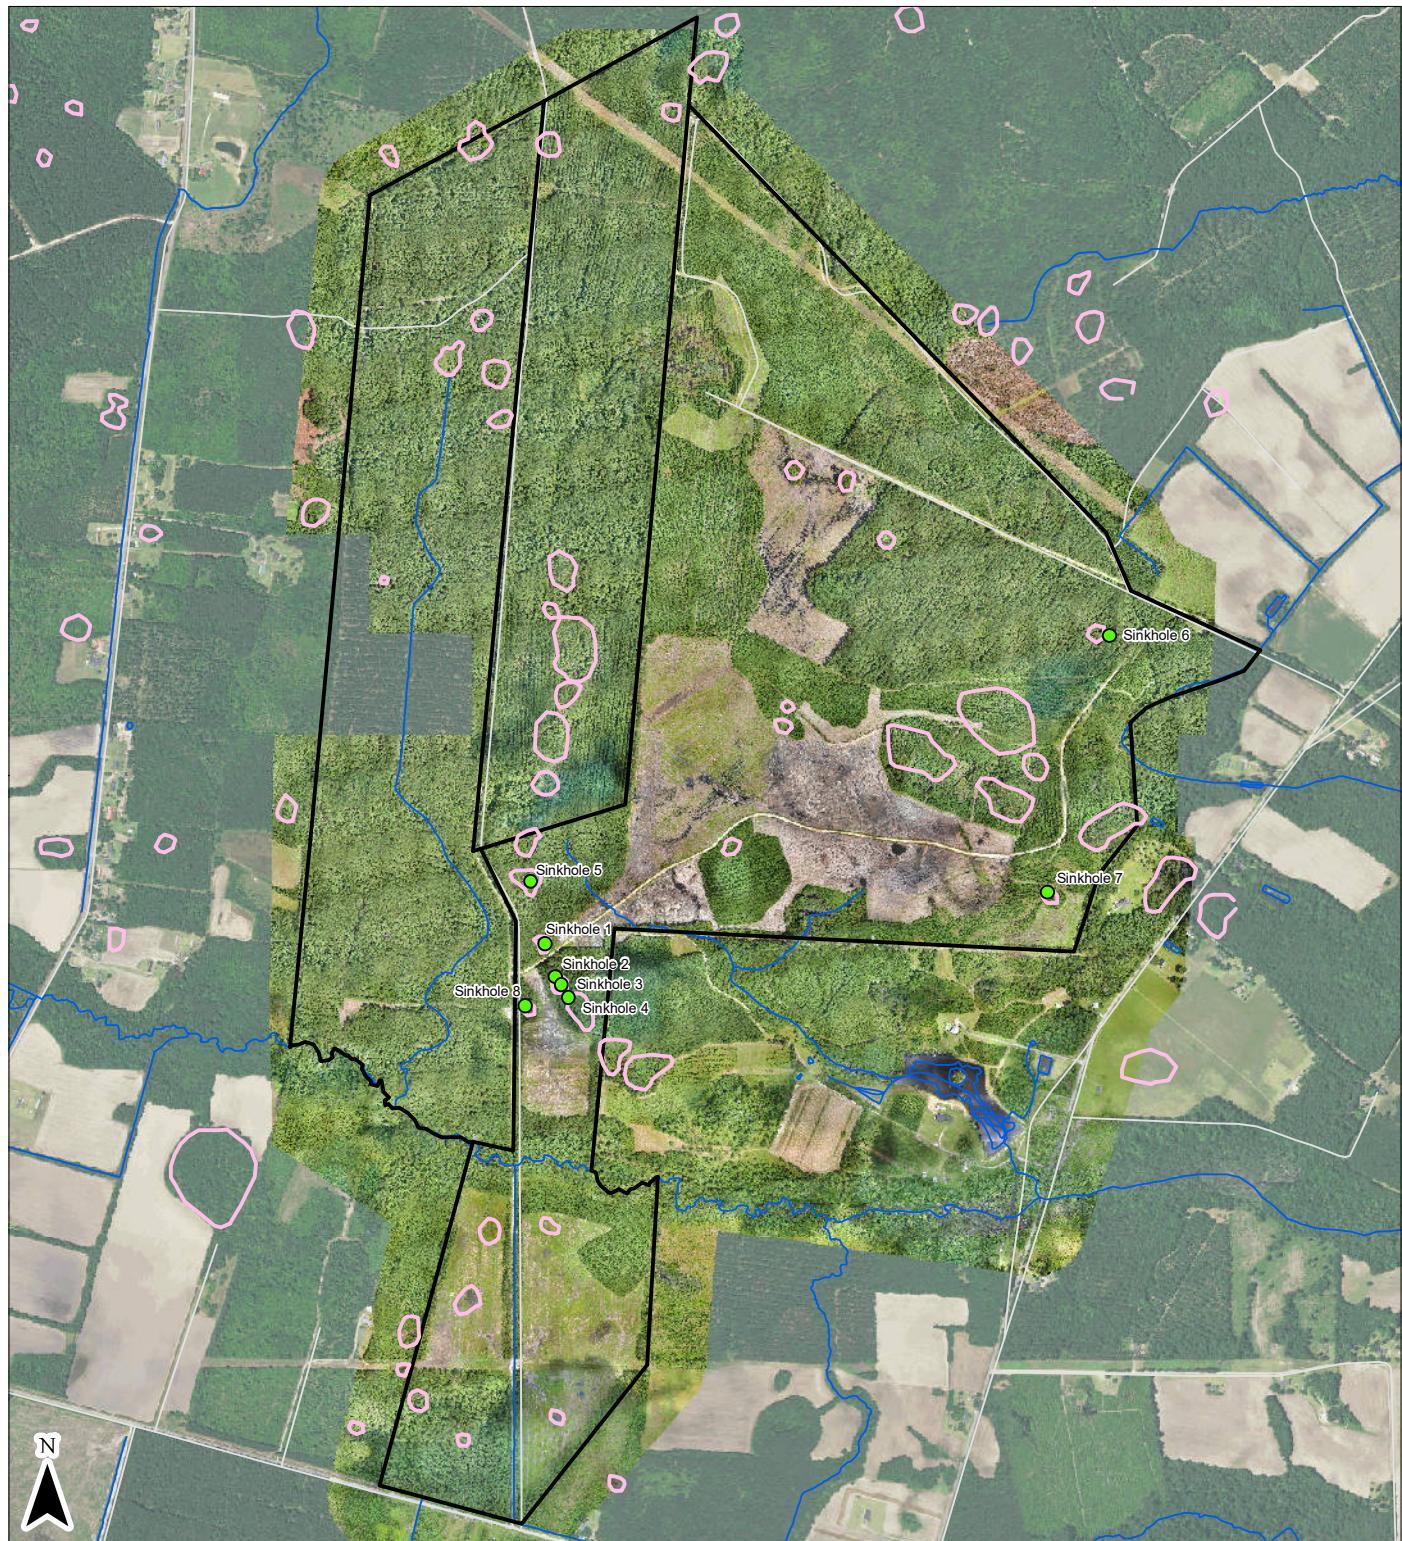
FIGURE 2

The baseline evaluations of surface depressions at the Andrews Quarry site revealed 8 depression ponds that exhibit the characteristics of sinkhole depressions (See Figure 2) (GMA, 2021). These closed depressions (named Sinkhole Pond 1 through 8) are deeper than other

Existing Sinkhole Features at the Andrews Quarry
